Ellyn Shea, Consulting Arborist

August 25, 2017

Assignment

The property owner, Max Ma, is developing a single-family residence on 3848 San Bruno Avenue in Brisbane. A 40-foot easement in favor of the San Francisco Public Utilities Commission (SF PUC) has been noted in the property's front yard, containing two underground pipelines. The SF PUC conducted a site visit and strongly recommends removal of all woody vegetation located on their easement. The City of Brisbane Planning Department (the City) concurred with this decision but requires replacement of any protected trees on the easement or on the private property itself at a minimum 1 to 1 ratio. Mr. Ma retained me to assess the property and provide an arborist report to accompany his development plans for approval from the City.

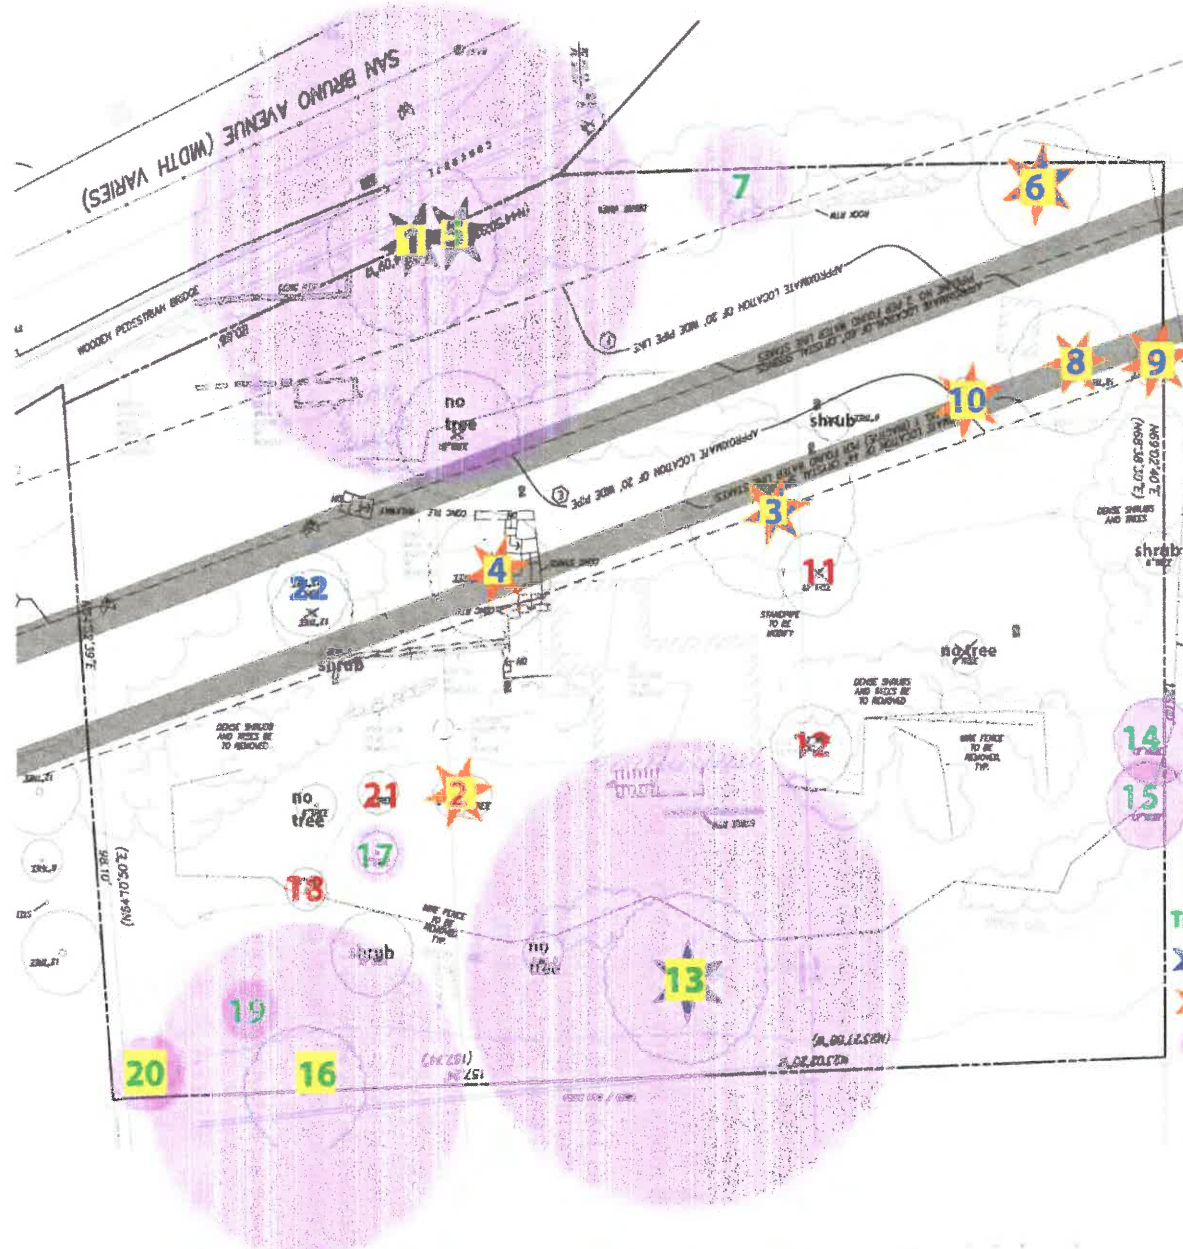
(E) SITE PLAN

- Up to 4 Protected Trees were noted:
 - Two are protected due to their species and size: Tree 5 and Tree 13.
 - One, Tree 1, is located on the boundary between private property and public right of way. The City may choose to consider this a street tree and if so, it would be protected due to its size.

- One collectively Protected Tree is present because 7 trees of more than 30 inches in circumference are proposed for removal at the same time. (Trees 2, 3, 4, 6, 8, 9, 10).

- Note: the final definition of “Protected Tree” is at the discretion of the City of Brisbane.
- 12 trees are proposed for removal, 5 due to proximity to proposed structures (according to the plan shown on Sheet A1.0 dated 7/7/17) and 7 due to interference with utility services (removal of woody vegetation growing on the easement strongly recommended by the SF PUC).

Place TPZ fencing around the exposed soil areas of the TPZ to prevent compaction. Where trees grow in groups a collective fence may be used. For example, trees 1, 5 and 7 could be collectively fenced, as could trees 14 and 15 or trees 16, 19 and 20.

Trunk protection is specified for Tree 13, and may or may not be needed for other trees to be preserved, depending on construction activities.

Install temporary irrigation within the TPZ fencing for trees 17, 14 and 15. Temporary irrigation should be installed above ground, not in trenches, using PVC pipe on undisturbed soil. The risers are attached to "T"s and elbows, as they would be in an underground system.

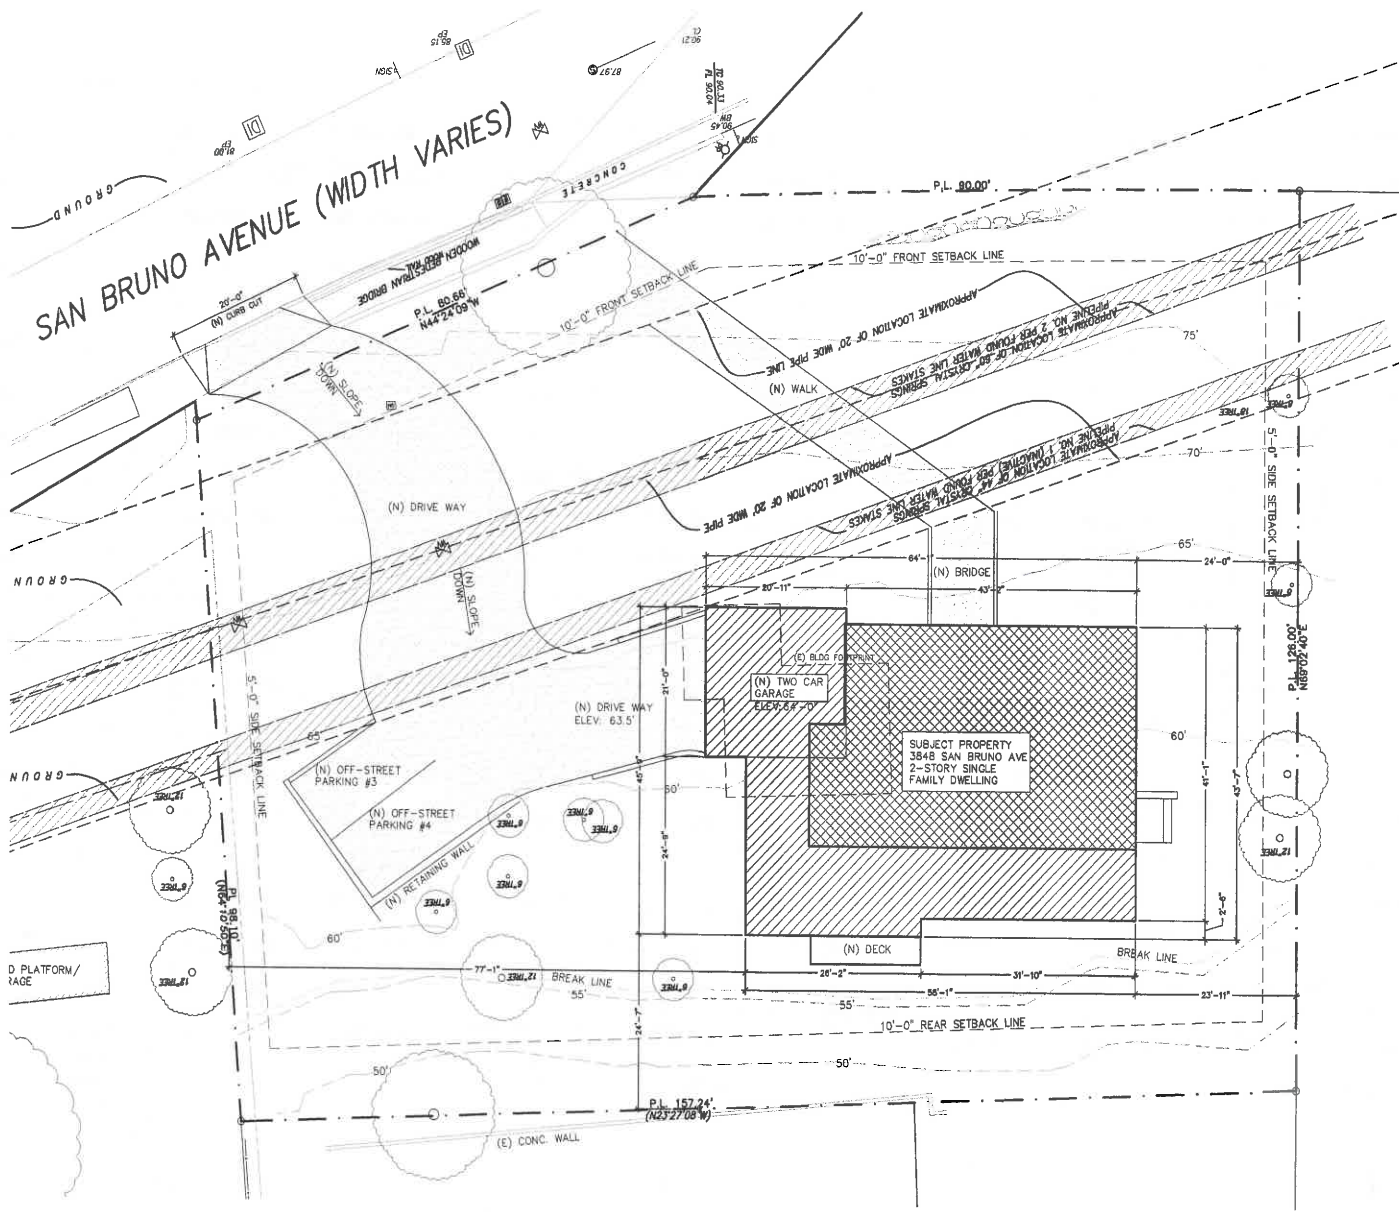
SITE PLAN & NOTES

Although Tree 13 is indicated for removal in Sheet A1.0 dated 7/7/17, this is a native tree in good condition and a protected species according to City ordinance. This tree should be retained and not have more than 25% of its living foliage removed. This report and all supporting documentation recommend its preservation, which may require design modification and will require proper preservation measures during construction.
