CITY OF BRISBANE

MEMORANDUM

To: Infrastructure, Utilities & Franchise Subcommittee via City Manager
From: Randy Breault, Director of Public Works/City Engineer
Subject: Intersection Analysis (3)
Date: Meeting of 5/19/16
cc: Police Chief, Deputy Public Works Director

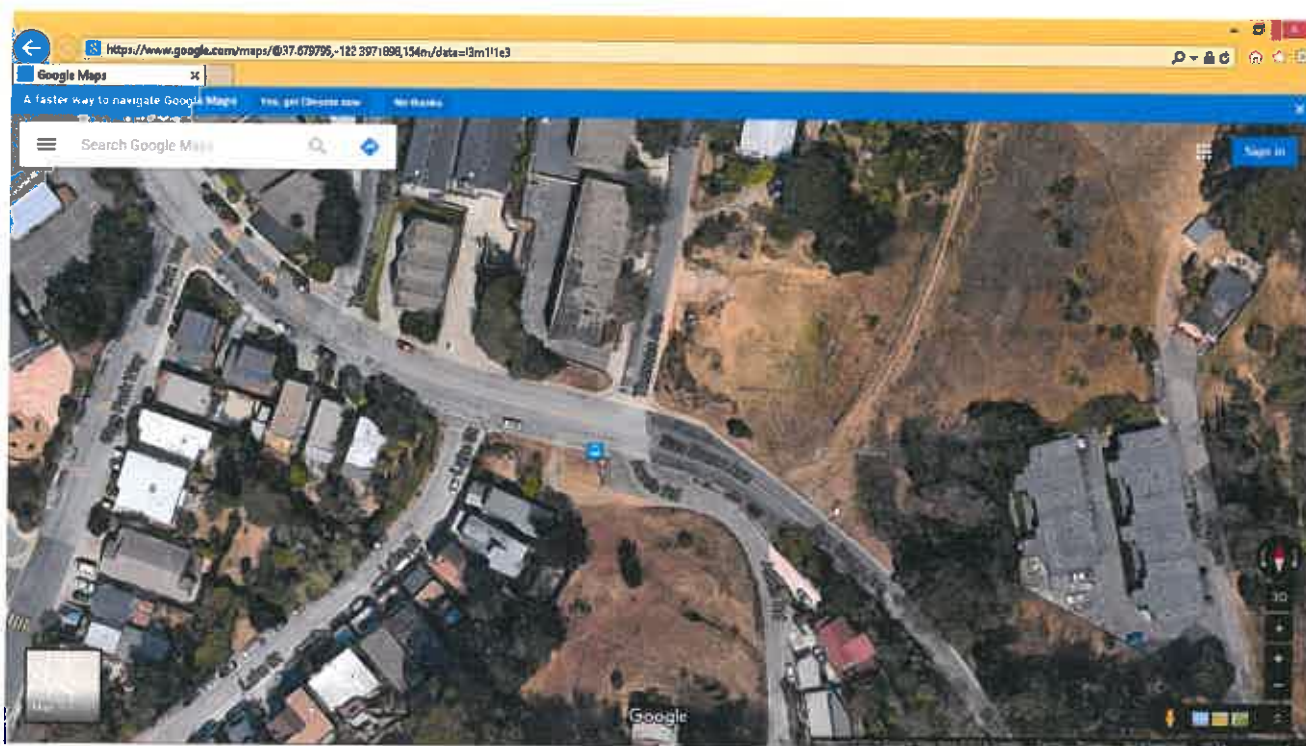
1. **Upper Segment of San Bruno Avenue, generally at the crest between the intersections with Thomas Avenue and Annis Road.**

The city received a citizen complaint regarding unsafe conditons on San Bruno Avenue, and requested the city place 2 stop signs on San Bruno, at its intersections with Thomas and Annis.

In the past three years, there is only one recorded accident in the vicinity of this location (Report #15-0827-003.) In this incident, a driver under the influence of alcohol was proceeding northbound on San Bruno, and shortly after the “intersection” in question made an unsafe turn into a housing area, subsequently rolling their vehicle and impacting other parked vehicles. Due to the PCF, there are no available tools that would likely have eliminated such an accident from occurring. This accident is currently being reviewed by the San Mateo County DA’s office.

The results of the traffic recorders being placed for two days showed that a total of 6,956 vehicles used this roadway during this time. The median speed was 18.3 mph, and the 85th percentile speed was 23.5 mph. From this data, the time period when an excessive number (much greater than 15%) of the vehicles are exceeding the posted 25 mph is 3 AM - 5 AM.

Based on this historical information, there is no warrant for the placement of stop signs at the requested locations. Should the subcommittee believe that some action is necessary, the City Engineer can support the following:

- Placement of signs on Thomas and Annis directing pedestrians to use the San Bruno crosswalk near Glen Park Way.
- Placement of No Left Turn signs on Thomas and Annis. (These could be 24-hour restrictive or only during specified time periods, presumably, the peak travel hours.) Before recommending this, the subcommittee might want to consider further the impact this restriction will have on the neighborhood west of San Bruno, specifically, how many cars would be forced to traverse a narrow section of Sierra Point, to reach Glen Park, and then join San Bruno near the school.

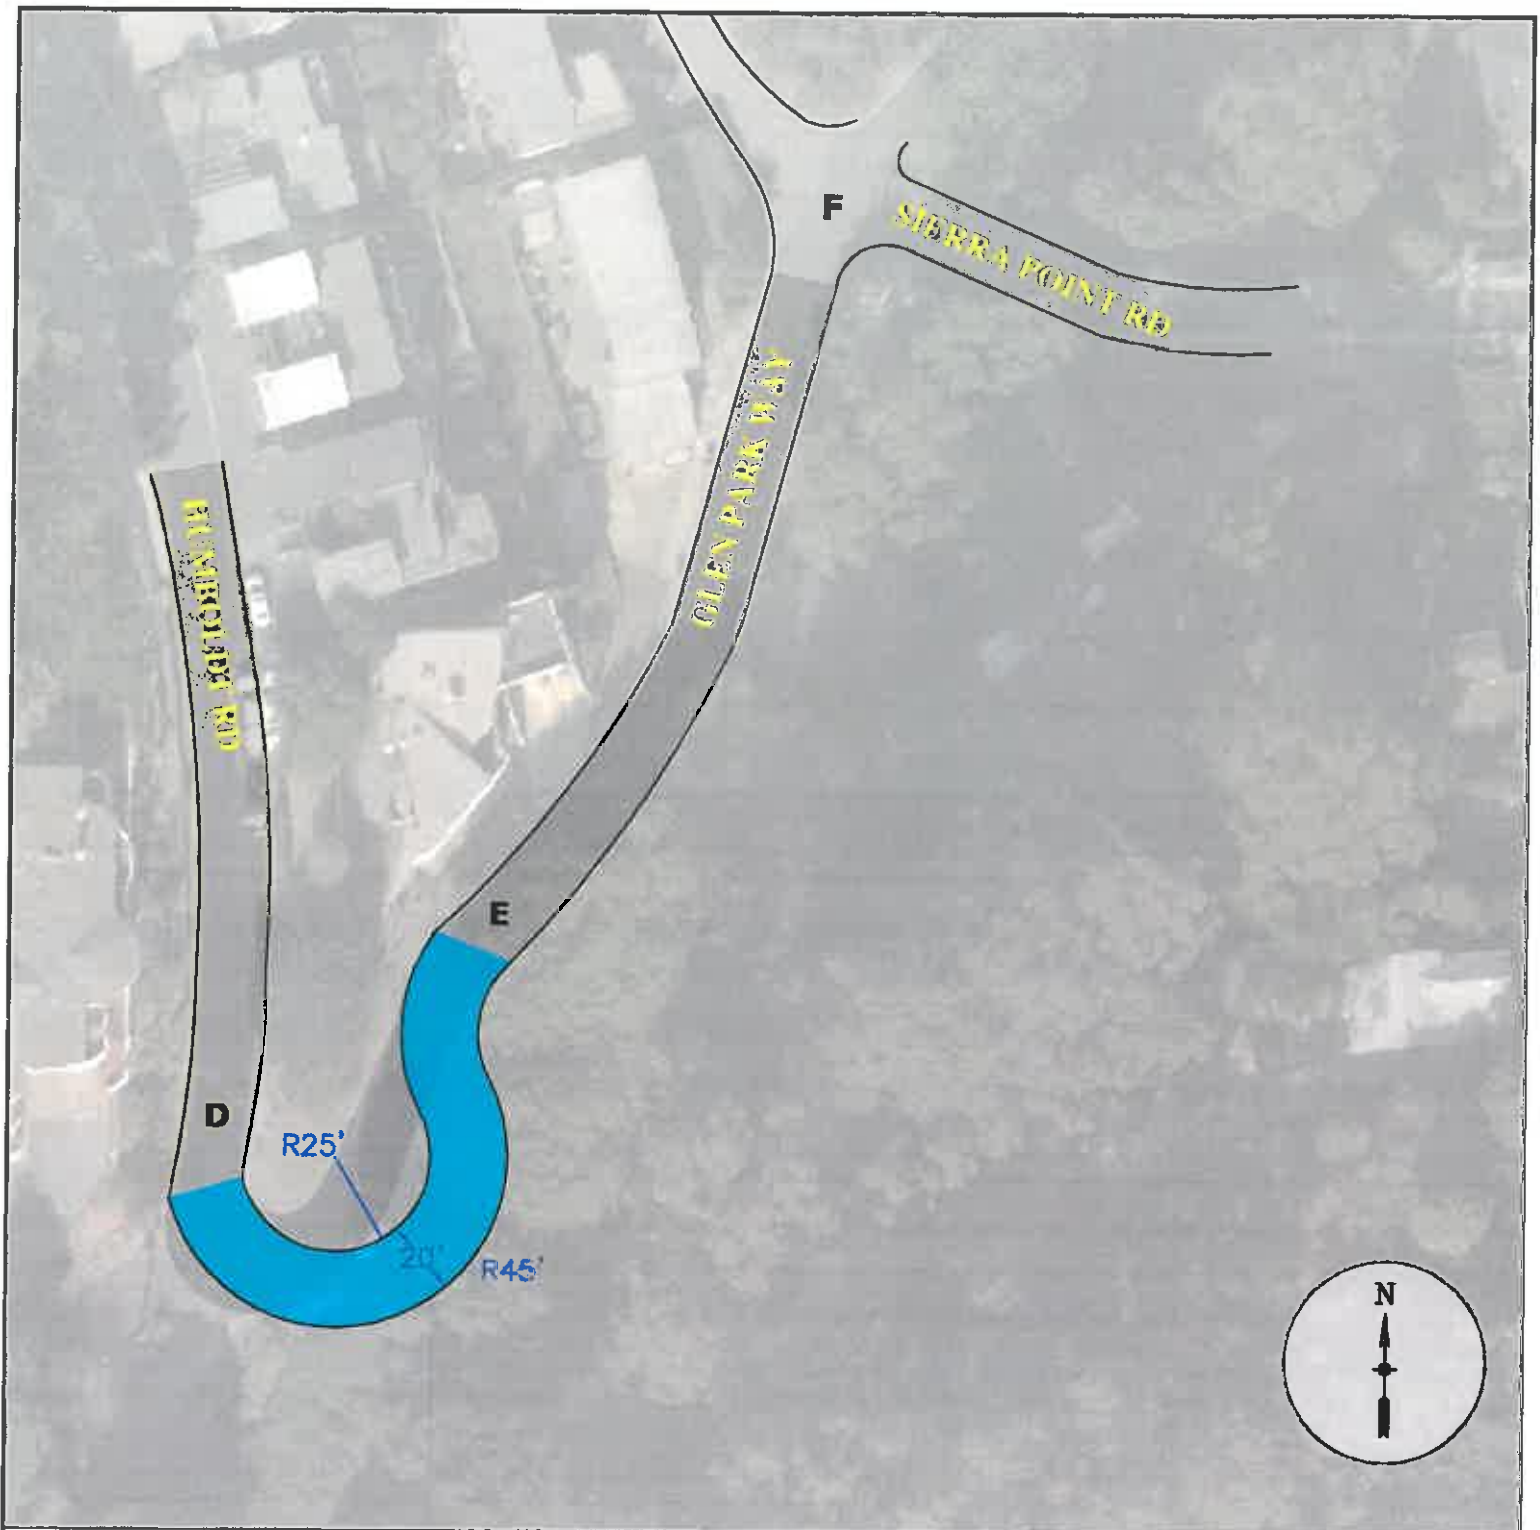
25' INNER RADIUS CORNER - GLEN PARK WAY TO HUMBOLDT ROAD

D - E : $10.0^\circ = 17.6\%$ slope

E - F : $10.3^\circ = 18.1\%$ slope

This option would relax the incline of the curve.

Staff assumed that the major encroachment into the canyon shown on the final bullet would not be palatable to the community. If the lesser encroachment shown in the second bullet is acceptable, staff would recommend the subcommittee direct staff to obtain a cost proposal for an engineering study to finalize a potential intersection realignment and cost estimate for the construction of it.

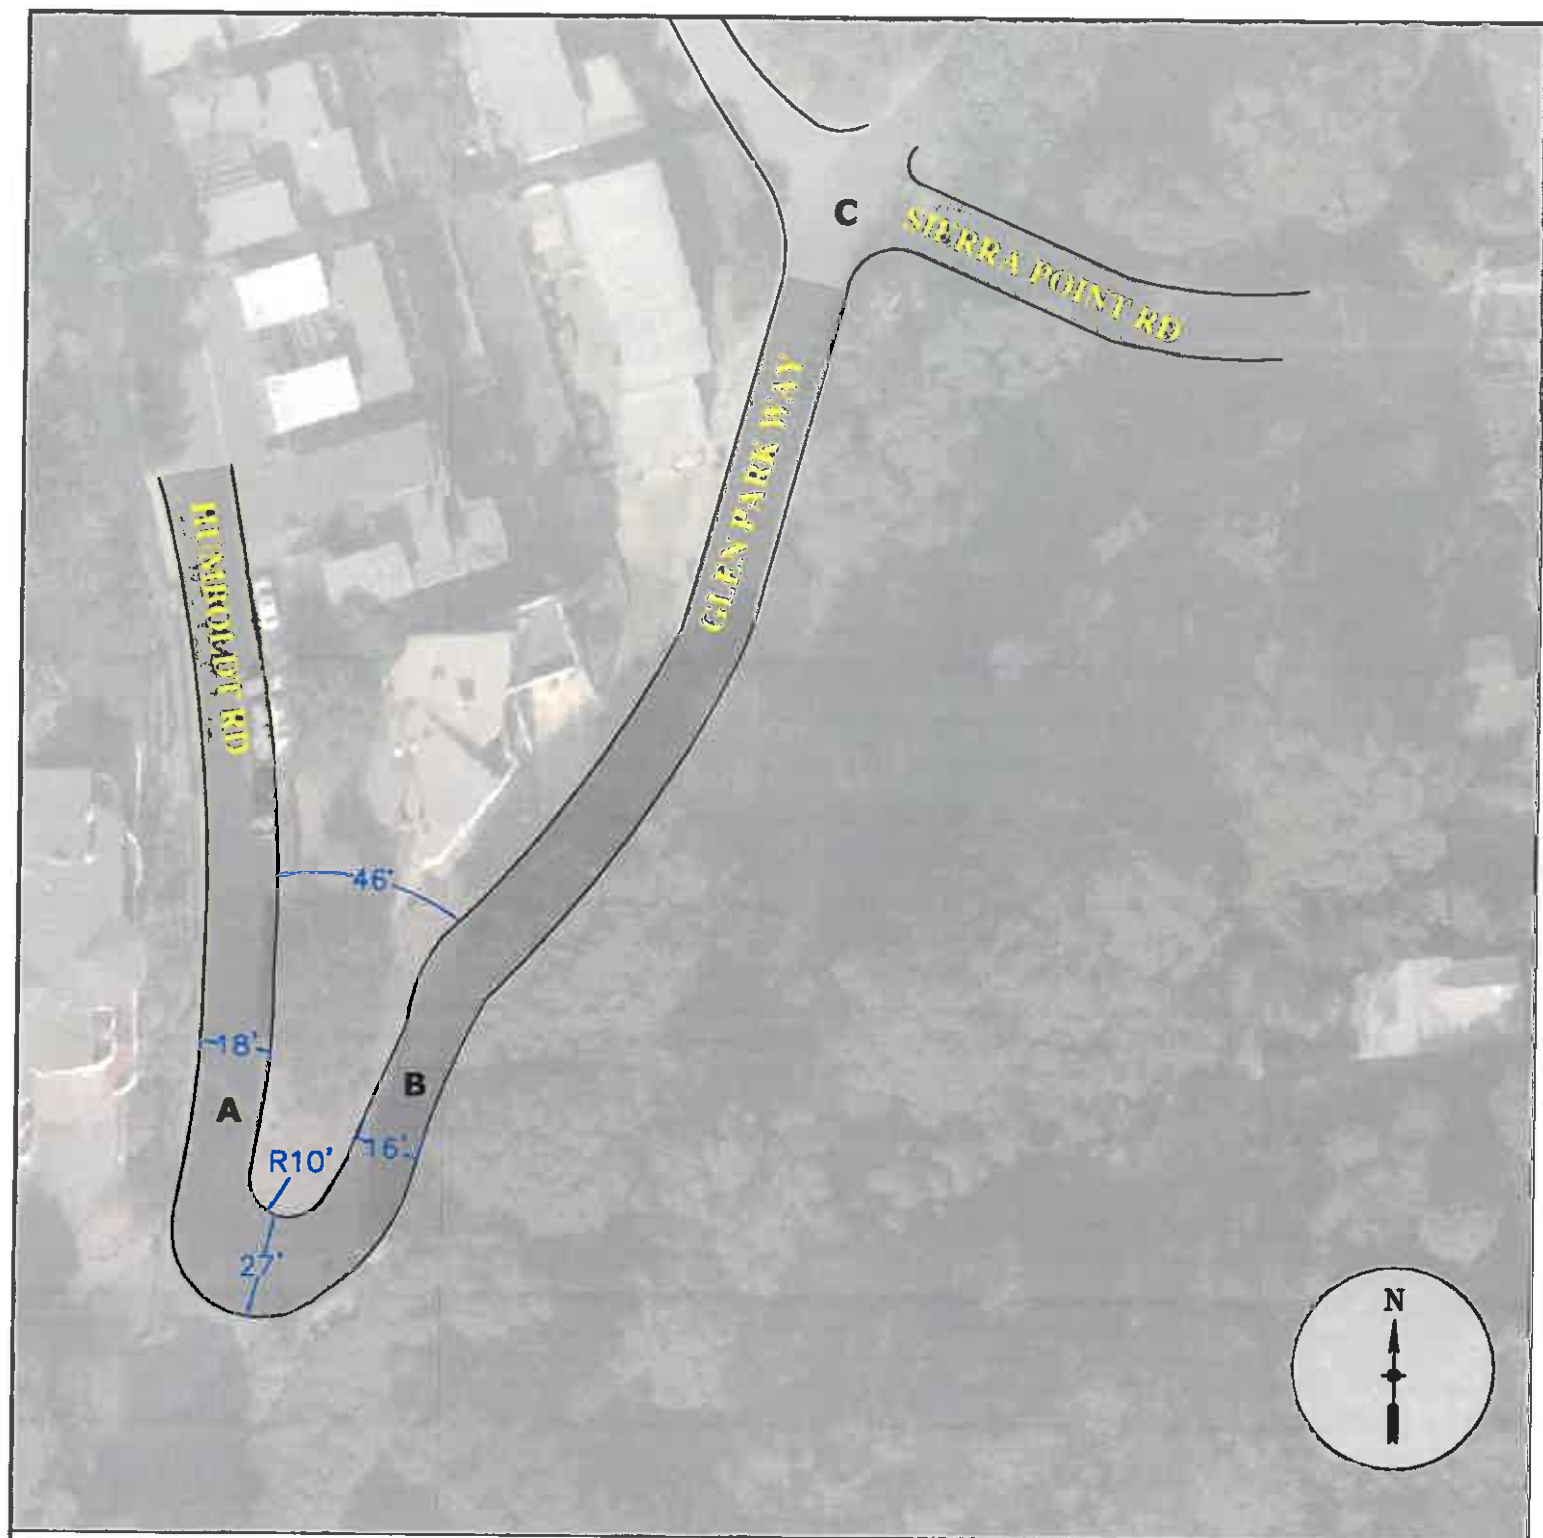
EXISTING 10' INNER RADIUS CORNER - GLEN PARK WAY TO HUMBOLDT ROAD

By modern engineering standards, this intersection is substandard on three counts; inadequate radius, excessive vertical slope, and inadequate roadway width. Within the limits studied here (Glen Park Way, between Humboldt and Sierra Point), there was one accident reported in the last three years. In 2015, a postal delivery vehicle turned left from Humboldt onto Glen Park, struck the curb/embankment, and then rolled. The driver was found to be at fault for an unsafe turning movement (CVC 22107(a)).

A - B : $11.4^\circ = 20.2\%$ slope

B - C : $10.3^\circ = 18.1\%$ slope

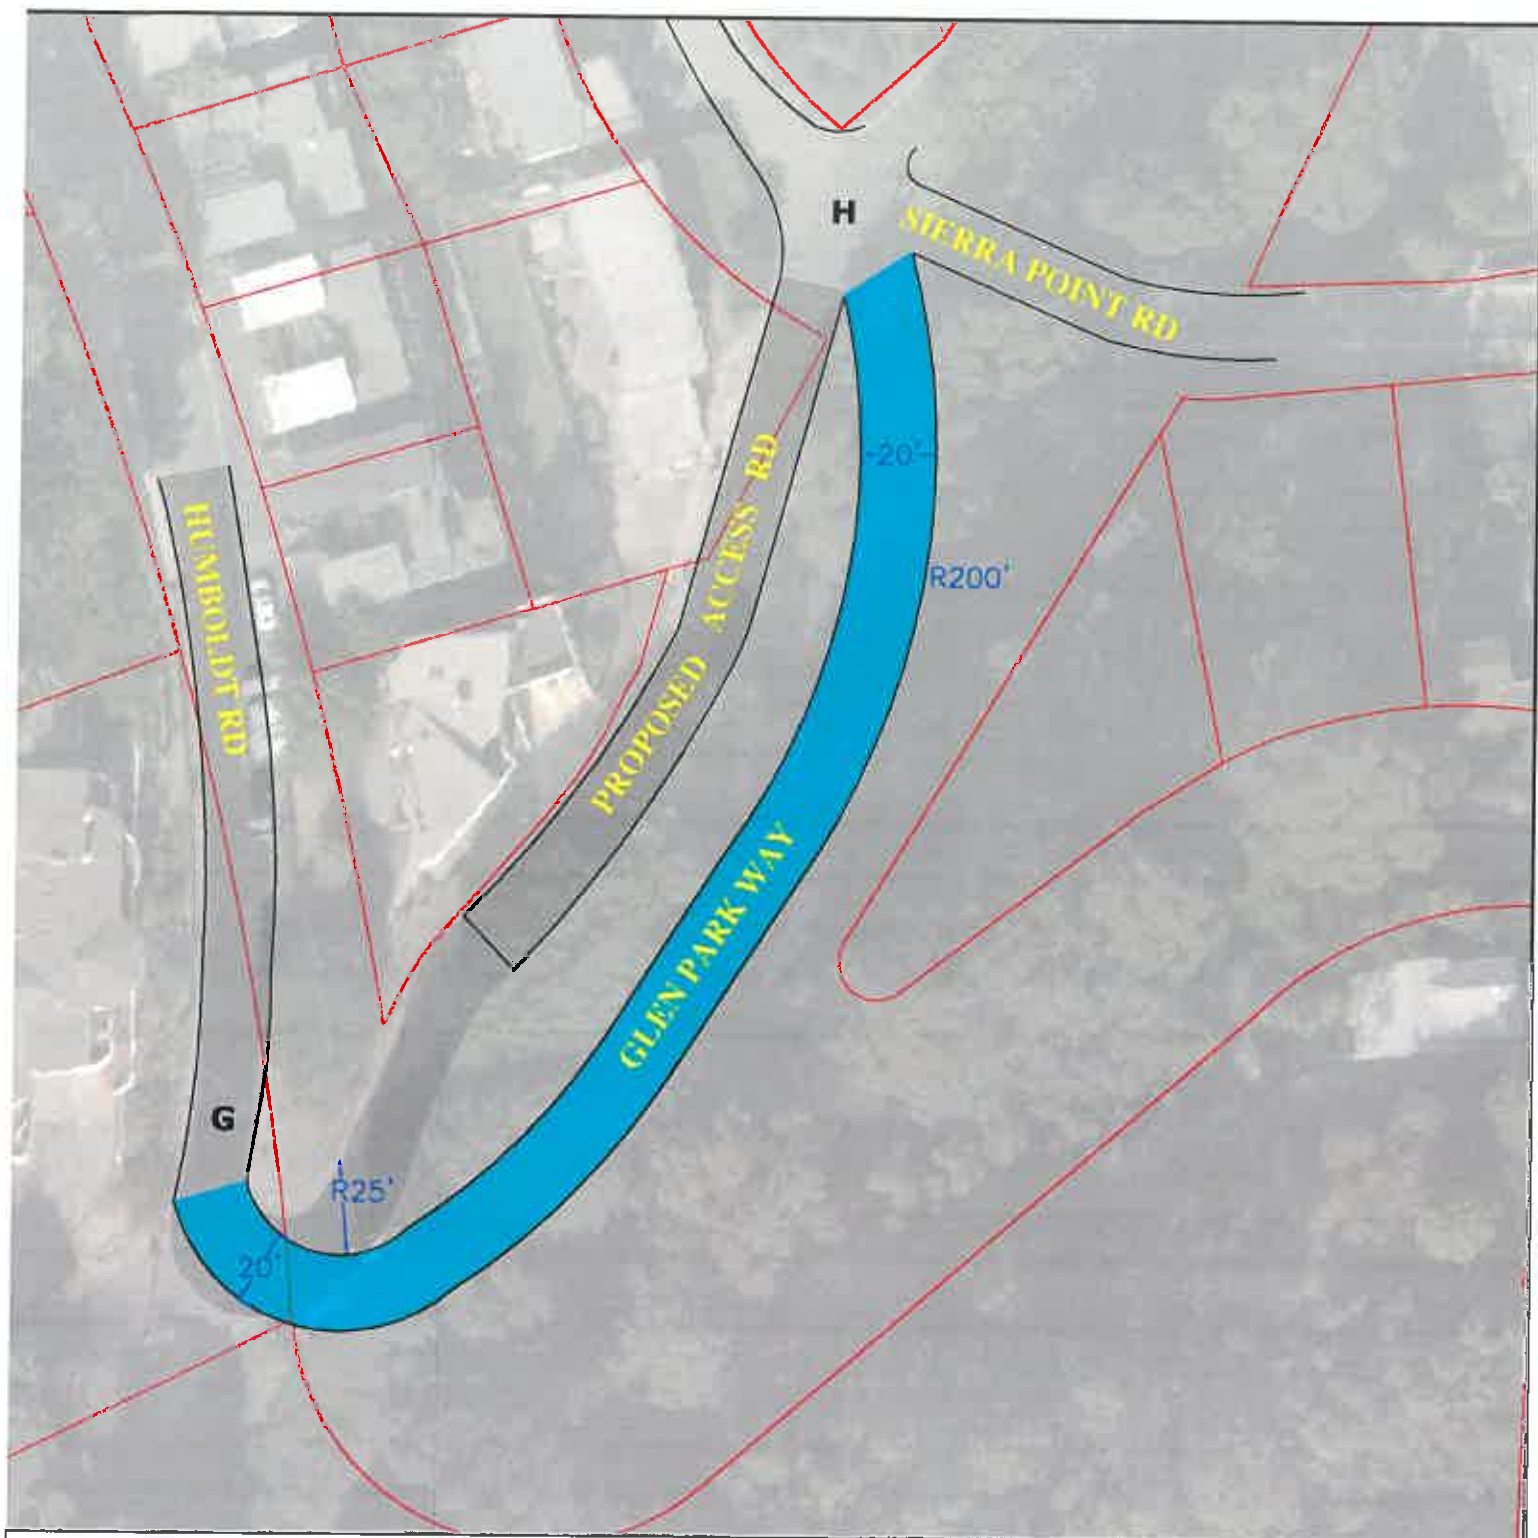
25' INNER RADIUS - 200' OUTER RADIUS - GLEN PARK WAY TO HUMBOLDT ROAD

G-H : $9.9^\circ = 17.5\%$ slope
