Biological Resource Analysis

99 Thomas Avenue
Brisbane, California

December 2017

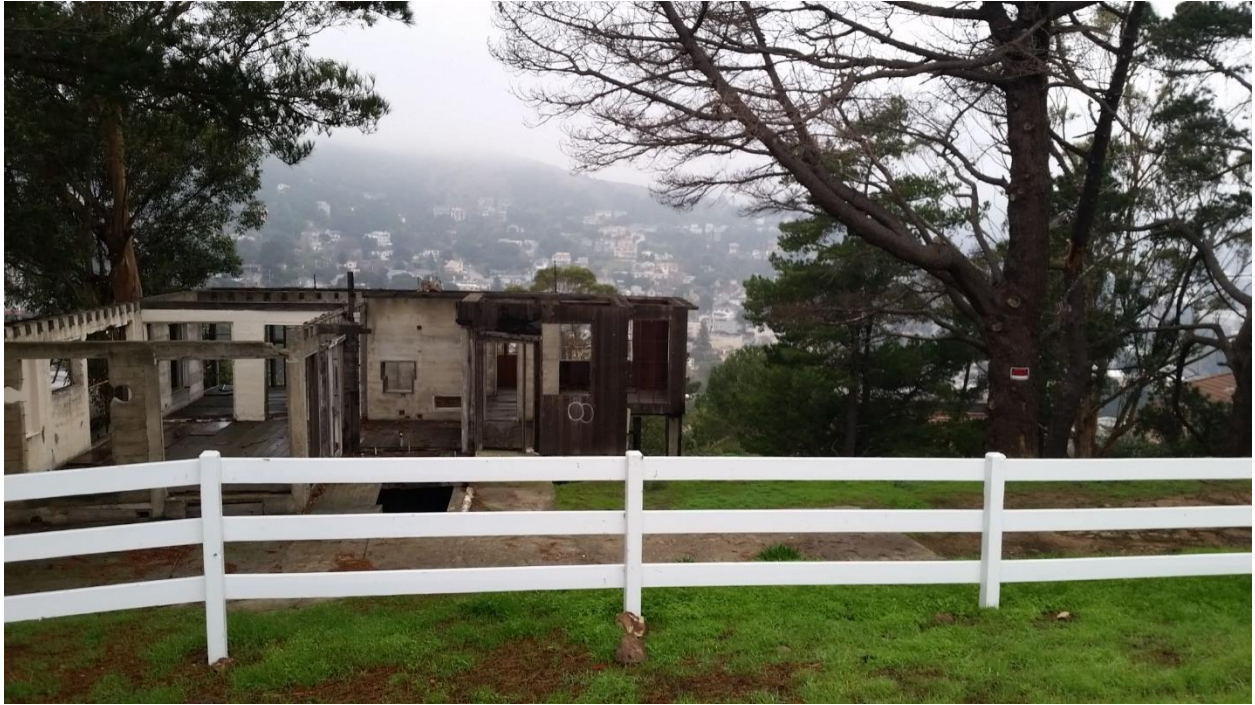
Photograph 1. Southernmost portion of the project site.
(Standing east of the project site - offsite - facing west)

*Note the abandoned structure

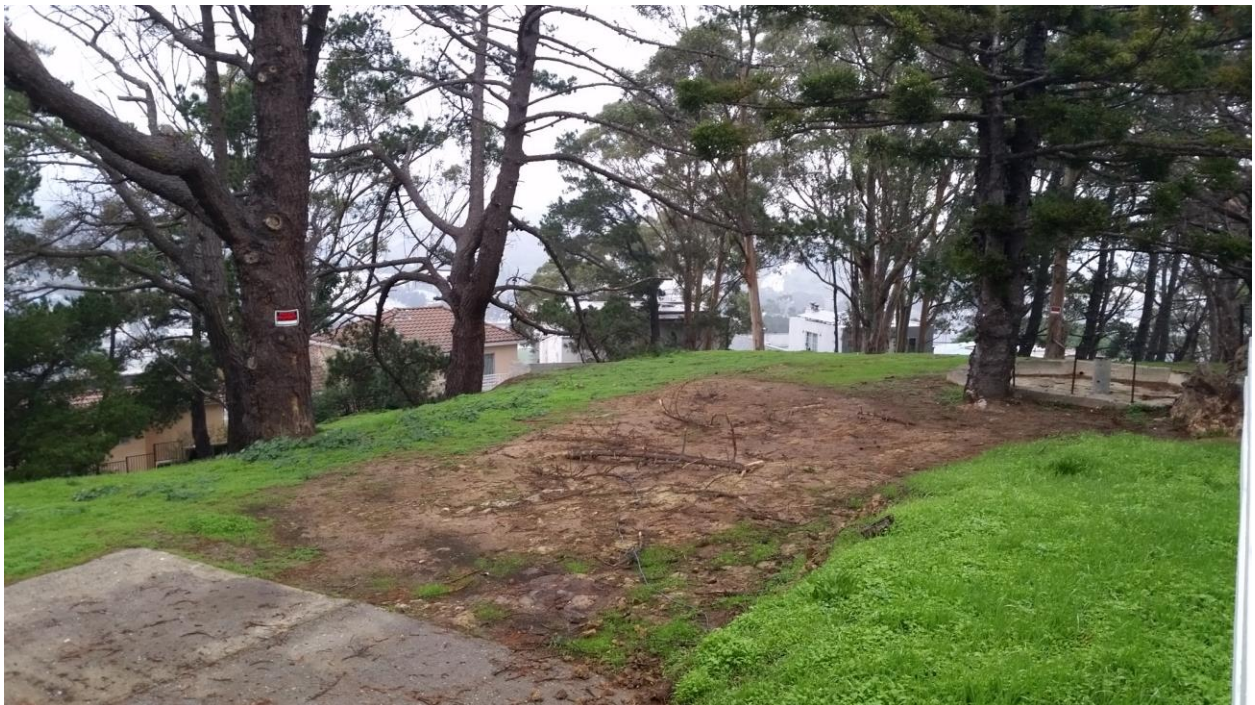
Photograph 2. Central portion of the project site.
(At end of existing driveway - southern portion of the project site - facing north)

*Note the disturbed nature of the project site

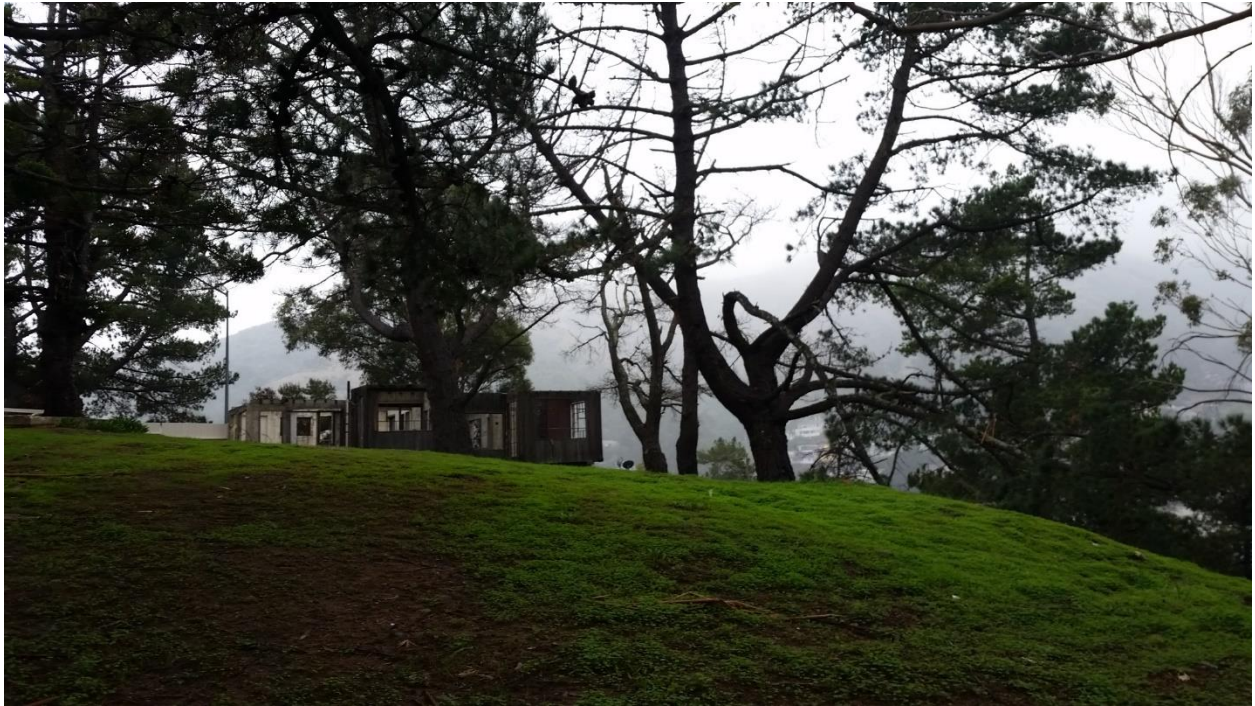
Photograph 3. Central portion of the project site.
(Standing at the northwestern end of the project site, facing southwest)
*Note the sparsely vegetated understory

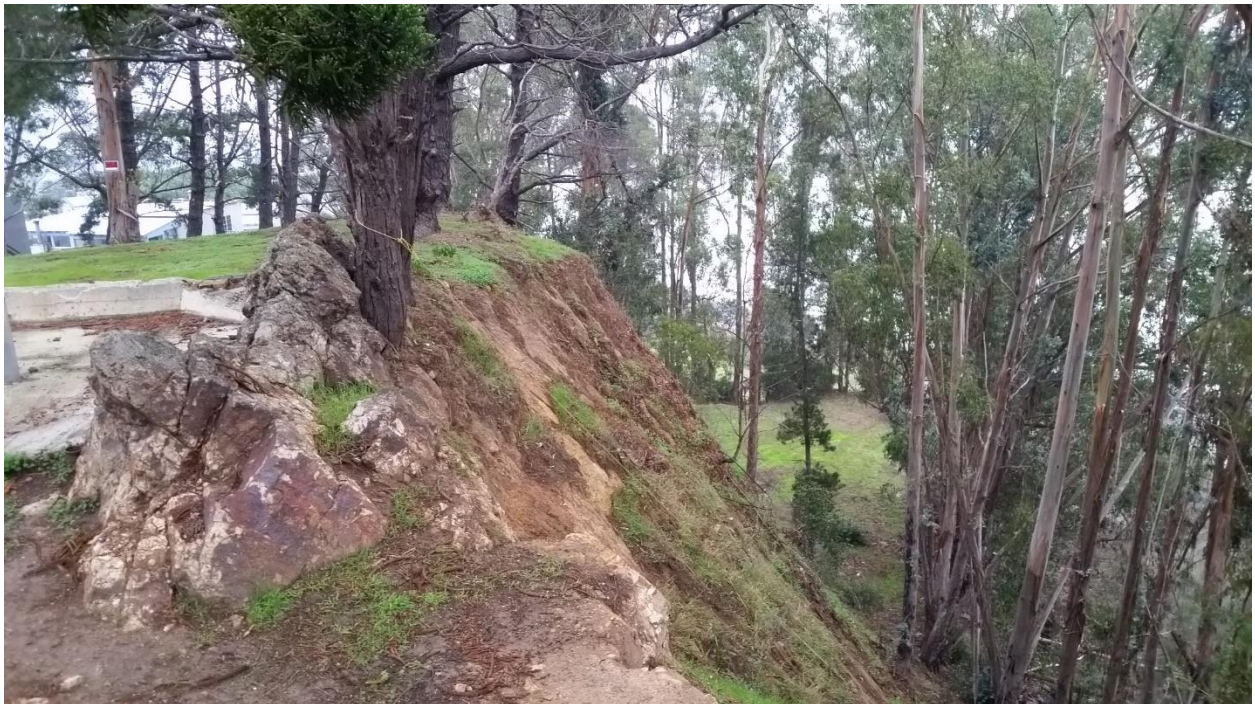
Photograph 4. Central portion of the project site.
(At east-central corner of the project site - facing north)
*Note the steep slope that bisects the property

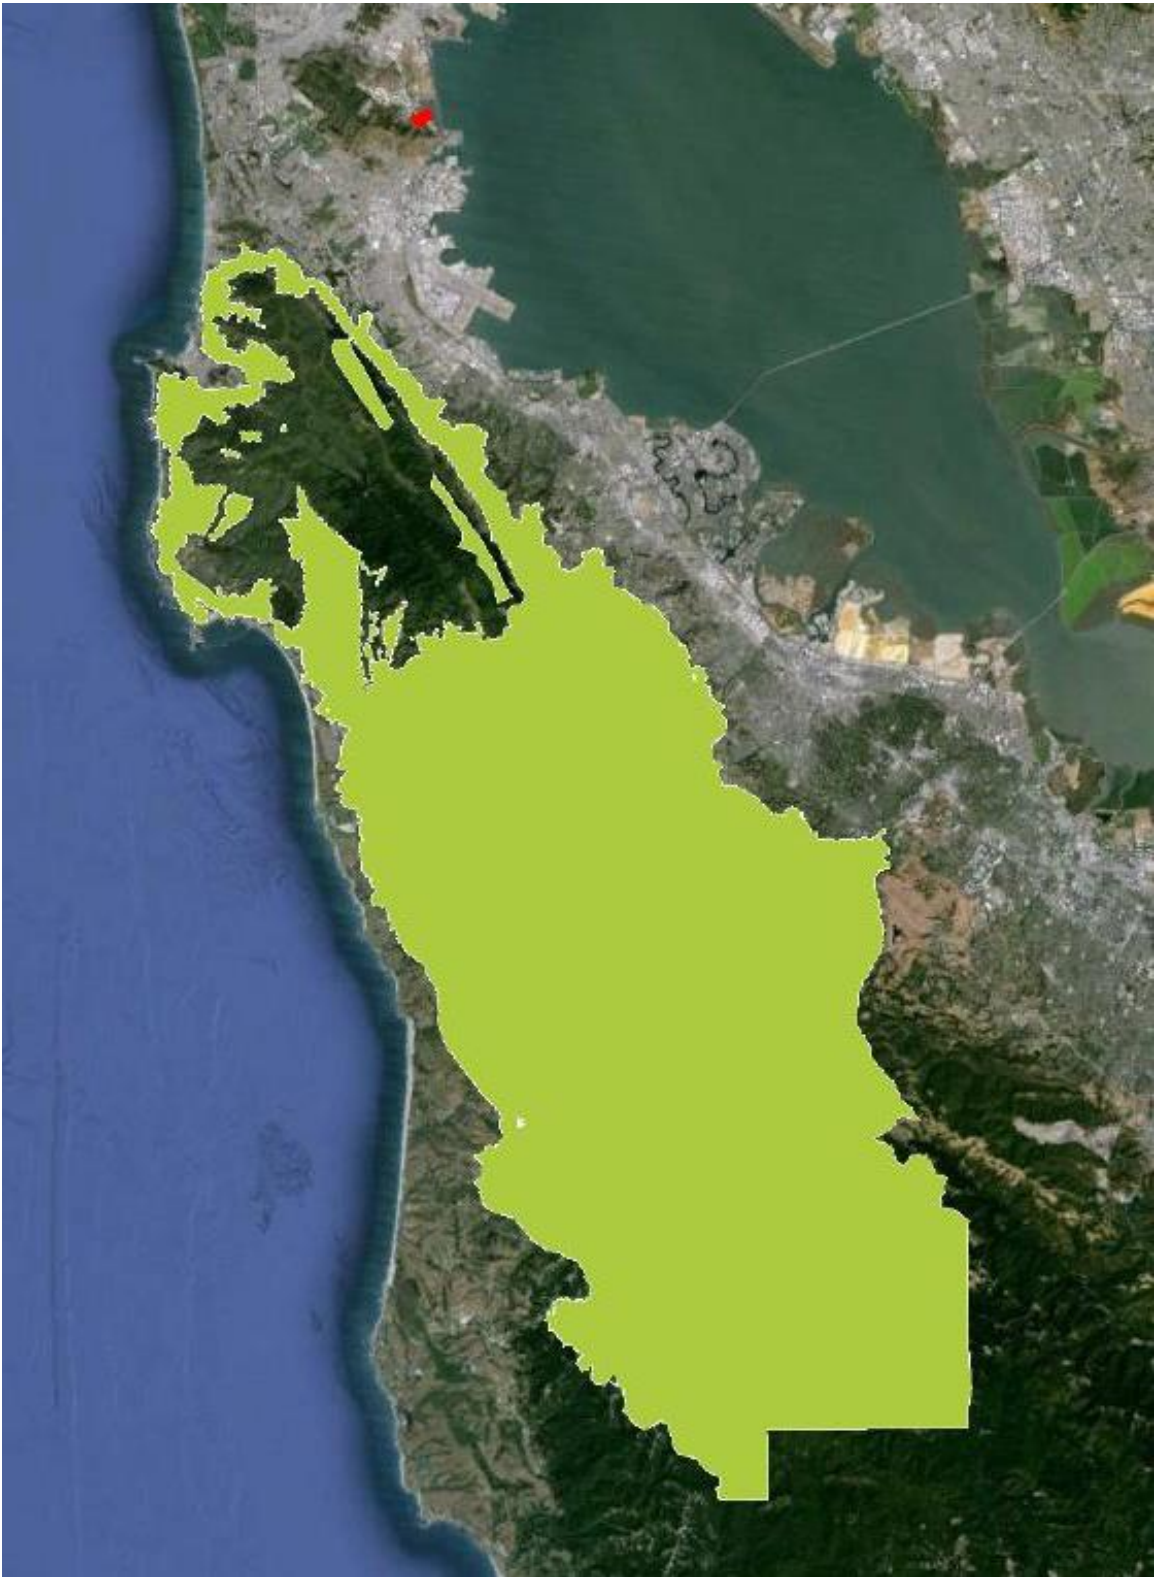
Essential Habitat Connectivity Areas in the Vicinity of the Project Site

*The project site is not located within any delineated Essential Habitat Connectivity Areas.

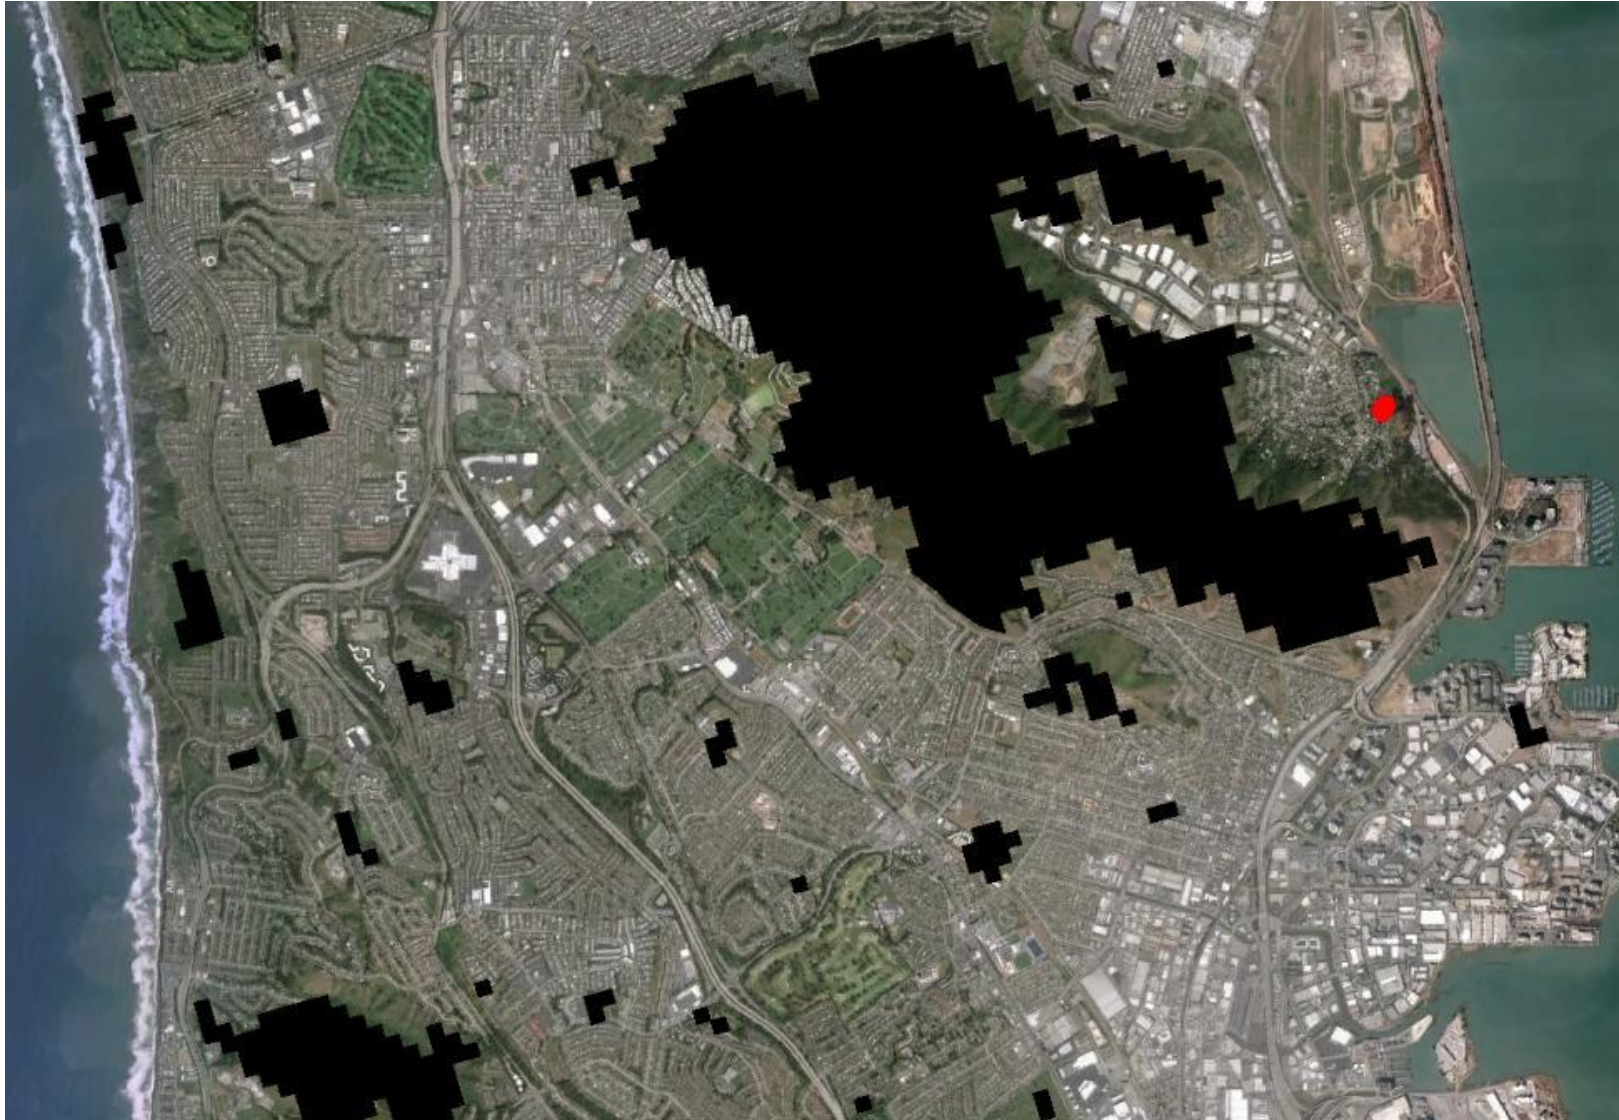
Natural Landscape Blocks in the Vicinity of the Project Site

* The project site is not separated from San Bruno Mountain by any delineated Natural Landscape Blocks.

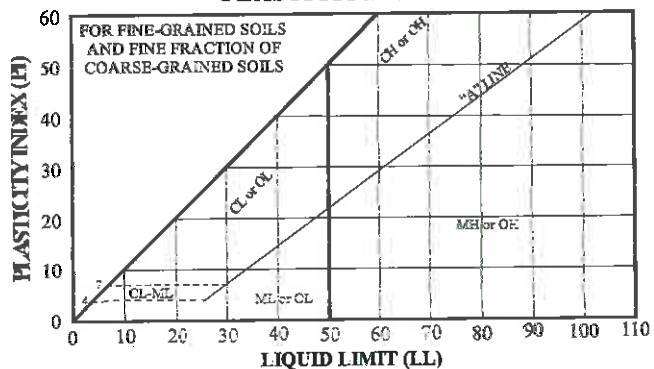
PLASTICITY CHART

Reference: ASTM D 2487-06, Standard Classification of Soils for Engineering Purposes (Unified Soil Classification System).
